Quick Report for the Ledgewood-Bonair Landslide, Whidbey Island, Island County, Washington

Department of Natural Resources, Division of Geology and Earth Resources

Summary of site conditions

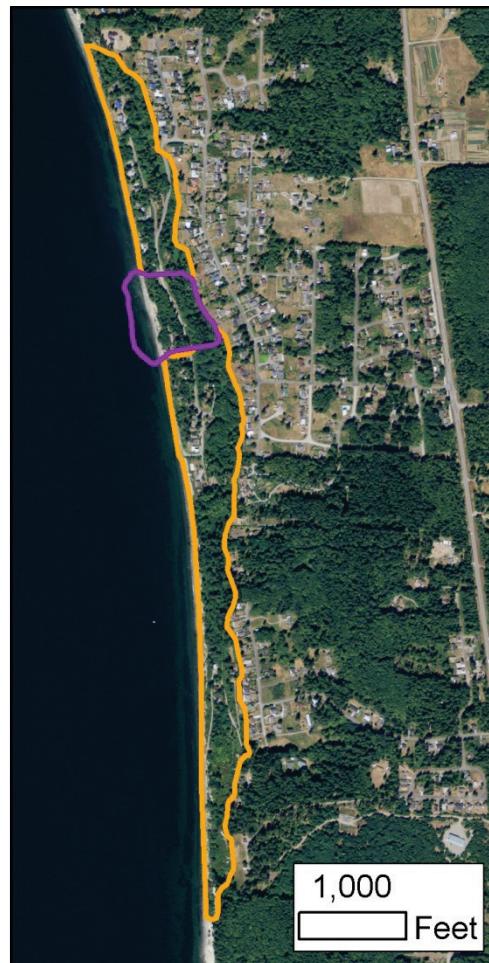
Figure 1. Reconnaissance map of the Ledgewood–Bonair Landslide. Purple outline is the approximate area of the landslide, based on reconnaissance-grade GPS, field observations, and oblique aerial imagery from news media outlets. The orange outline is the area of the prehistoric landslide most recently mapped by Polenz and others (2009).

The Ledgewood–Bonair Landslide (LB Landslide) on Whidbey Island, Island County, Washington occurred around 3:45 am on March 27, 2013, and is a small portion of a much larger landslide complex (Fig. 1). The larger landslide, which is approximately 1.5 miles long, is prehistoric and may date back as much as 11,000 years. The LB Landslide is likely a reactivation of a small portion of the prehistoric complex. The dimensions of the landslide are approximately 1100 feet long (measured parallel to the shoreline) and about 300 feet into Puget Sound. Initial estimations place the volume of material mobilized as great as 200,000 cubic yards (~40,000 dump truck loads).

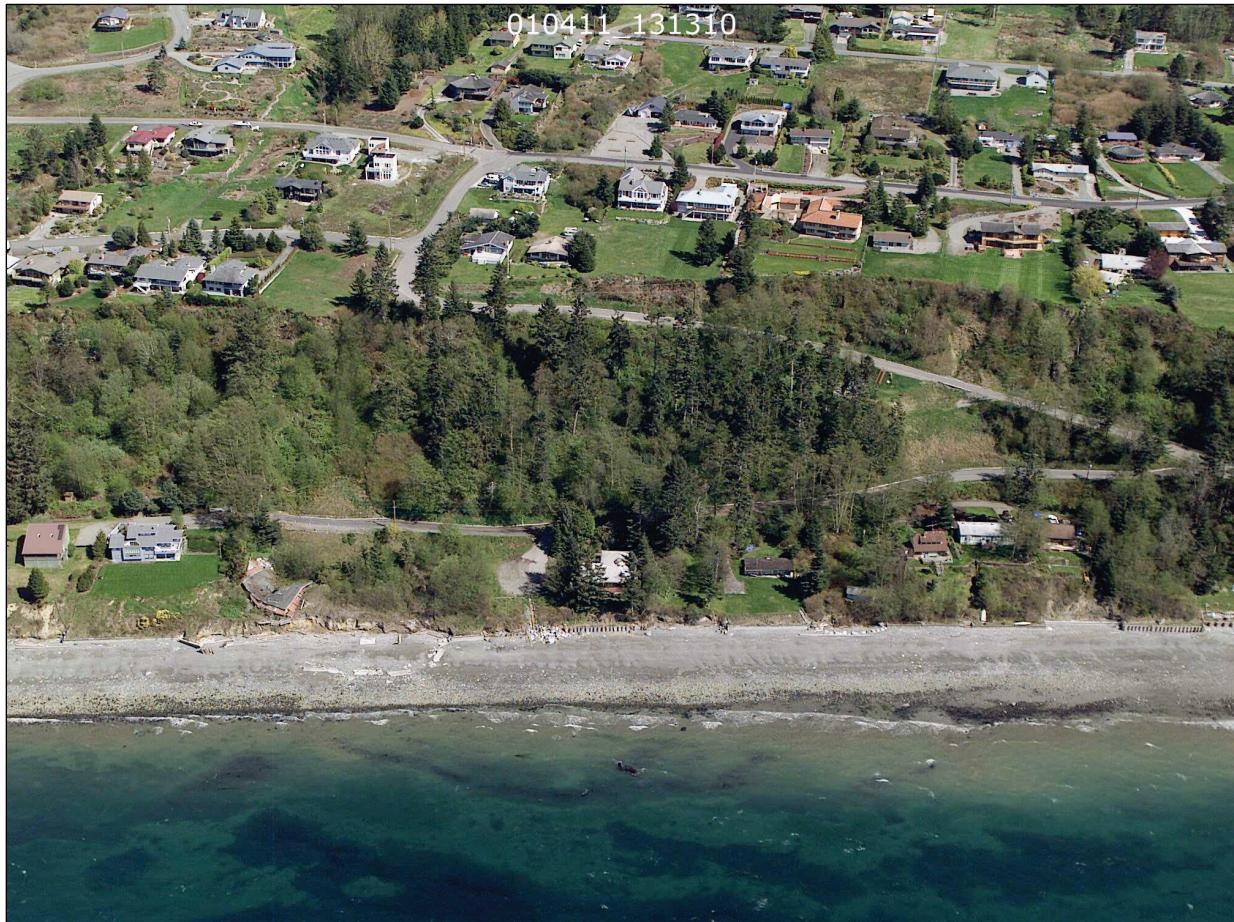
Figure 2. Oblique aerial image from 2001 showing a landslide that occurred in 1996–1997. The house is on the beach in the lower left corner of the photo and is located approximately 800 feet north of the Ledgewood–Bonair Landslide. Image is from the Dept. of Ecology.

DNR geologist Michael Polenz identified the affected slope as a prehistoric landslide in 2005, and that finding was later published as part of a geologic map of the Camano quadrangle (Polenz and others, 2009, (http://www.dnr.wa.gov/Publications/ger_gm68_geol_map_camano_24k.pdf)). Polenz's field notes from 2005 identify a large landslide complex from the top of the slope, about 200 ft above sea level, to the shore and include references to the work of Jerry Thorsen, an earlier DNR geologist, who noted episodic slide activity that affected at least one small portion of the larger landslide complex between 1981 and 1997. Thorsen noted that this landslide activity demolished a beachfront residence over a period of time from 1996 to 1997 (Fig. 2), approximately 800 feet north of the LB Landslide.

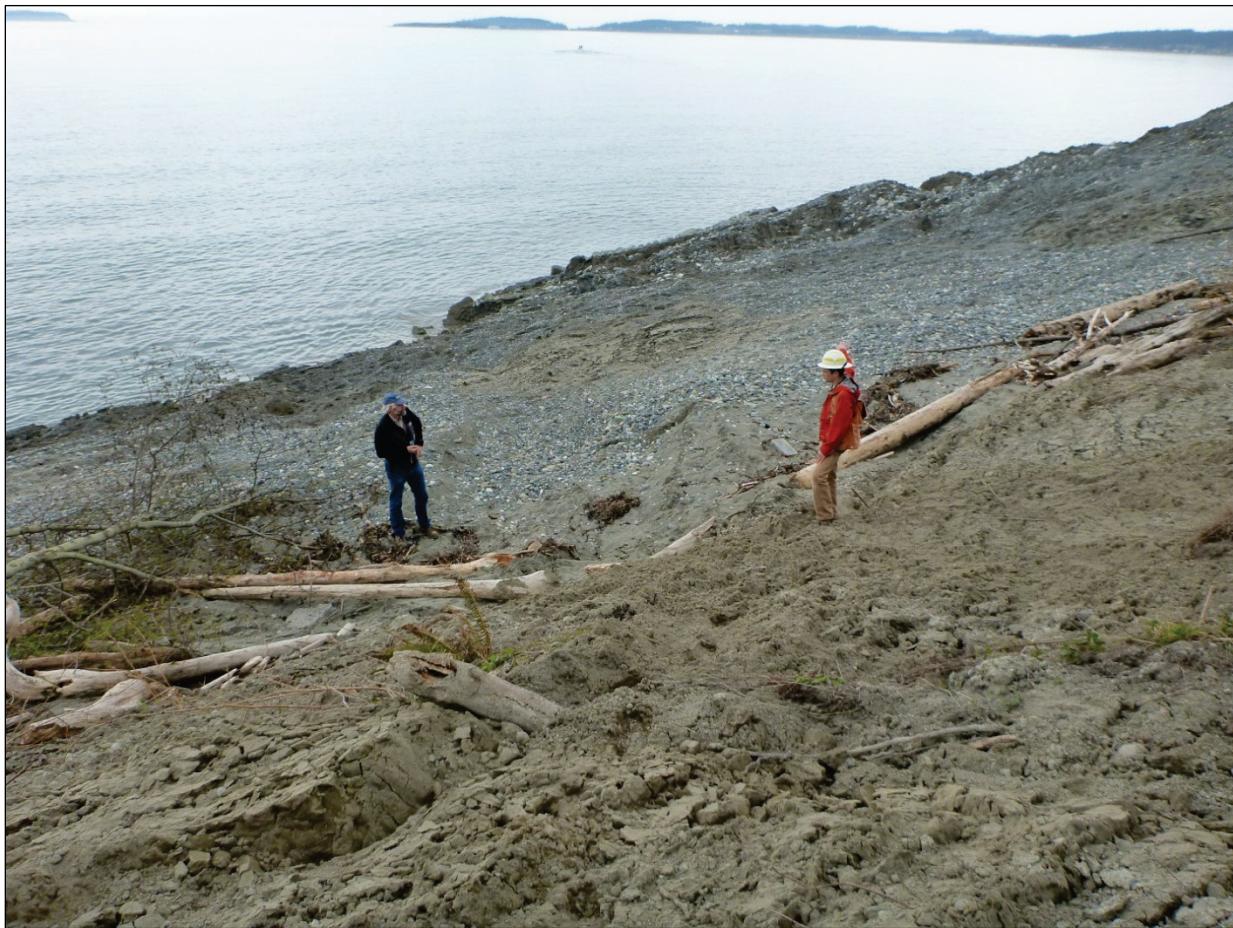
Figure 3. Geologists Hugh Shipman (left, Dept. of Ecology) and Stephen Slaughter (right, Dept. of Natural Resources) are standing between driftwood that is approximately 30 feet above the previous beach.

When we arrived on site in early afternoon, we started at the north side of the landslide near the intersection of S. Driftwood Way and Seaward Way. Power lines lay on the road and S. Driftwood Way ended at a 30-foot drop off onto the landslide body. We heard a tree crack and fall somewhere on the landslide body, a potential signs of landslide movement. At the beach, the toe of a deep-seated landslide failure plane uplifted the pre-existing beach as high as 30 feet above the shore (Figs. 3 and 4).

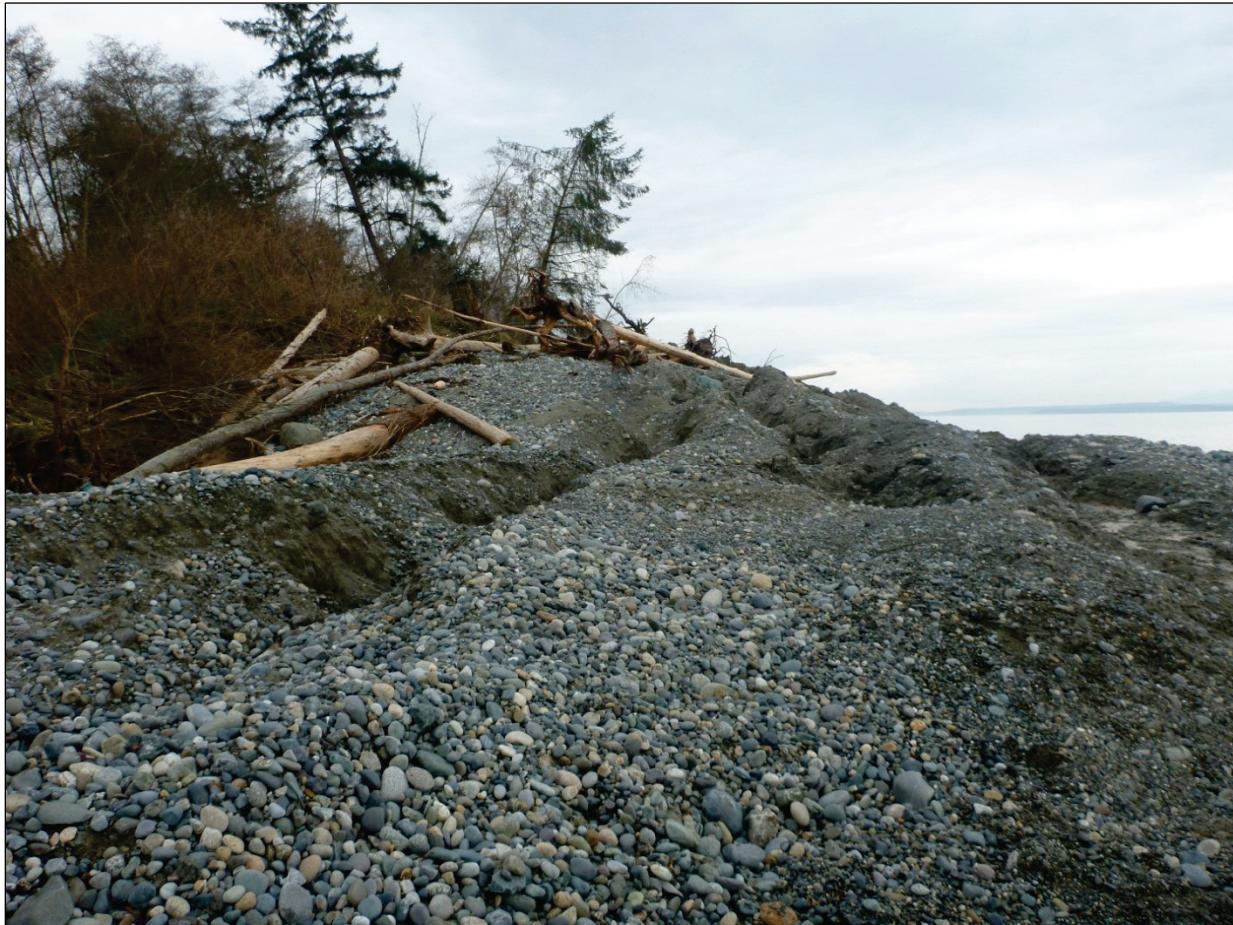
Figure 4. Uplifted beach on the Ledgewood–Bonair Landslide is a high as 30 feet. Note the jack-strawed fir trees in the background, a sign strongly suggestive of deep-seated movement and major disturbance of the subsurface.

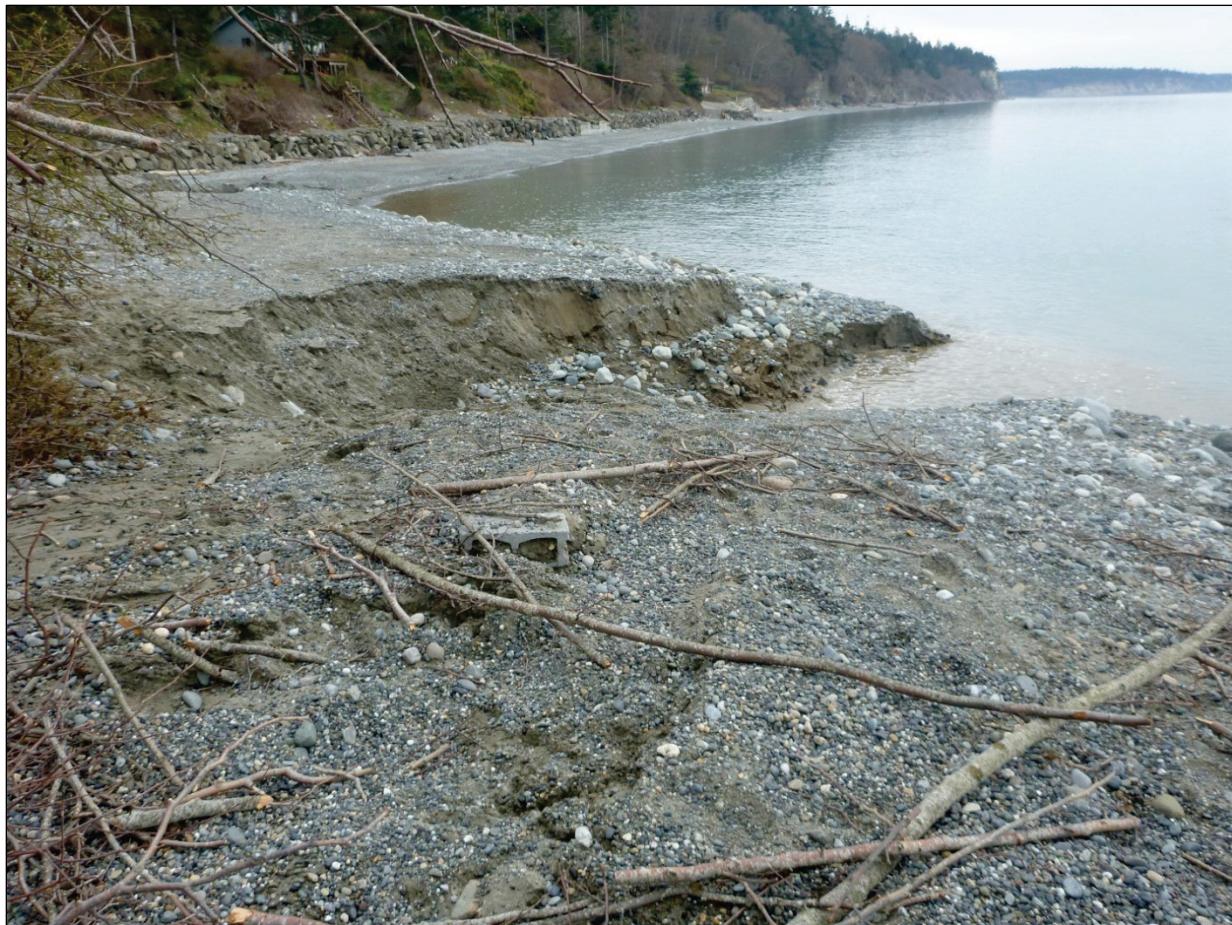
Figure 5. Southern portion of the toe of the Ledgewood–Bonair Landslide. The break in the surface of the toe is interpreted as one of several radial cracks further incised by tidal and wave action.

This movement suggests the deep-seated failure plane is located below sea level, and the depth is unknown at this time. Uplift of the beach is presumed to have been relatively slow (that is, over a few minutes) due to a lack of dewatering features observed on the uplifted beach (Fig. 5). The landslide occurred at approximately 3:45 am, roughly an hour before an 8.4-foot high tide. Deformation in the toe zone is extensive. Radial cracks extend perpendicular to the lobate toe, with radial cracks prevalent at the northern and southern margins of the toe. Wave and tidal action are actively eroding the toe, with small sections (1-10 cubic feet) observed calving with the rising tide. Transverse cracks parallel to the edge of the toe have deformed the uplifted beach in numerous locations, with cracks up to 35 feet long and up to 4 feet vertical displacement. A driftwood line is still evident, as well as dried seaweed from a previous high tide. GPS measurements of the toe suggest it is slightly over 1100 feet long and extends approximately 300 feet into Puget Sound.

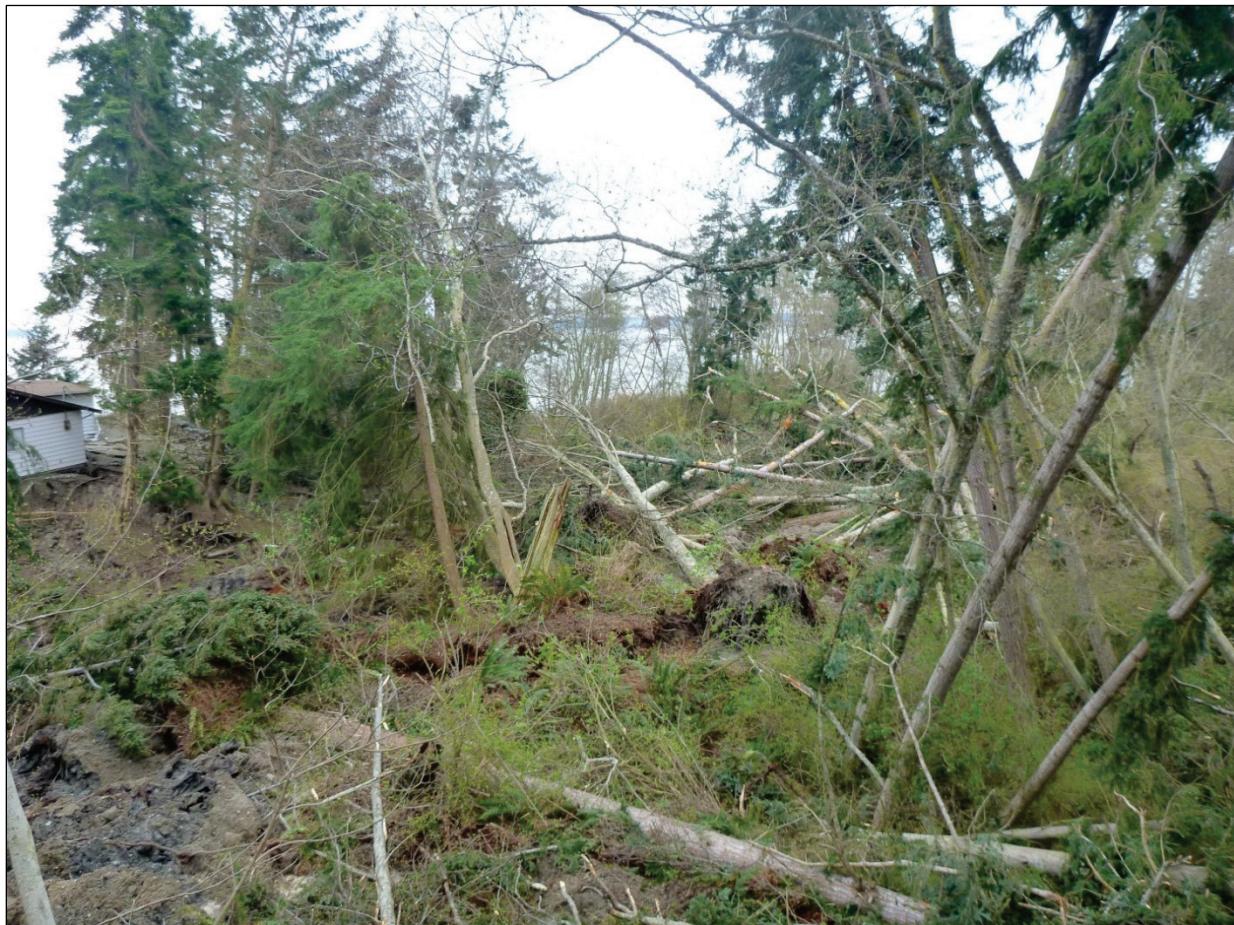
Figure 6. Body of the Ledgewood–Bonair Landslide. Jack-strawed fir trees were occasionally falling and cracking on the afternoon of March 27, 2013. Note the house on the left that was severely damaged by the landslide and pictured by most media outlets.

The body of the landslide, as observed from a safe distance, is hummocky with jack-strawed trees (Fig. 6) throughout much of the body. Where observed, the access road has been shifted approximately 80 feet down vertically and to the west. Initial GIS analysis of the area suggests the volume of material mobilized may be as great as 200,000 cubic yards. The same GIS analysis of aerial imagery from 2002 to

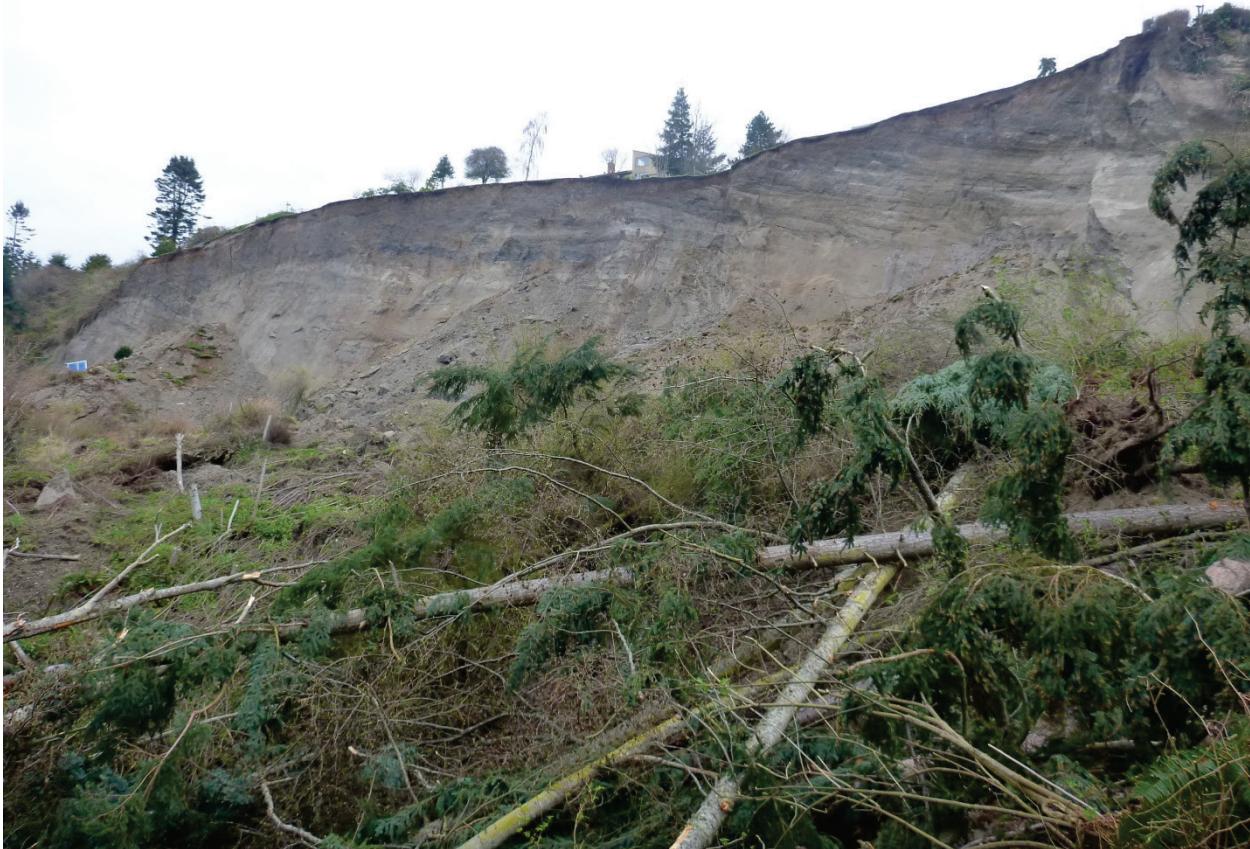
Figure 7. Headscarp of the Ledgewood–Bonair Landslide. The headscarp appears vertical to sub-vertical and exposes the glacial geology of the area. Colluvial wedges were actively forming on the scarp as overhanging debris fell from upper portions of the scarp. The top of the scarp averages 200 feet above sea level.

The headscarp appears vertical to sub-vertical and exposes the glacial geology of the area (Figs. 7 and 8). Colluvial wedges were actively forming on the scarp as overhanging debris fell from upper portions. The top of the scarp averages 200 feet above sea level.

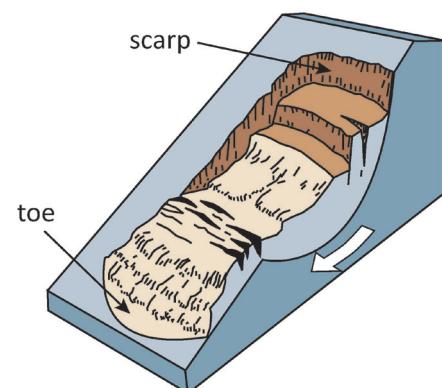
Figure 8. Diagram of a rotational landslide
